TECH TIPS

Applications: 2010 – 2012 Buick LaCrosse
2010 – 2012 Buick Regal
2010 – 2012 Chevrolet Camaro
2010 – 2012 Chevrolet Equinox
2010 – 2012 GMC Terrain
2011 – 2012 Chevrolet Cruze
2012 Buick Verano
2012 Chevrolet Sonic

TSB_1039.docx

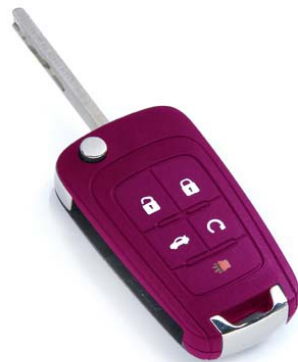
Cause: A potential cause for the above is the head of the key fob. When the key is unfolded from the key fob and not allowed to fully swing out the system cannot establish communication with the transponder built into the key fob.

Correct Key Position

Incorrect Key Position

Correction: Verify if the customer is aware of this condition and if not advise them to allow the key to fully swing out from the key fob.
