# TECH TIPS

**Dixie Part Numbers:** A-1645

**Applications:** 2010 Chevrolet Express (G Series) Van  
2010 GMC Savannah (G Series) Van

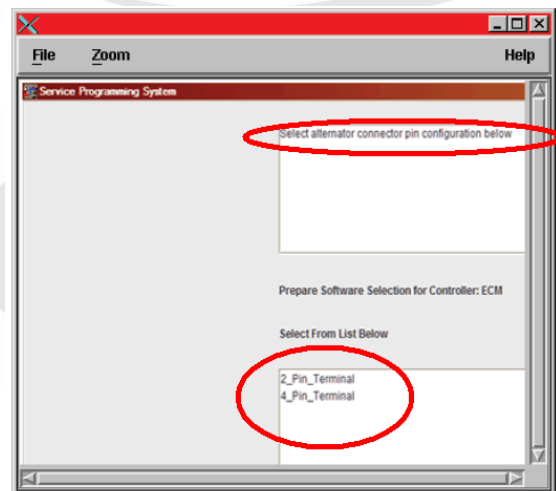
**Conditions:** The technician may comment or complain that the alternator is not functioning correctly when replacing the alternator. Additionally they may observe that there are 2 or 4 pins on the regulator connector from the unit being removed and the one being installed may have a different number of pins.

**Cause:** A potential cause for this is that there are both 2 and 4 pin configurations on the factory installed alternators and on the service parts. Both are correct but do not communicate with the ECM in the same way.

**Correction:** When replacing the alternator follow the vehicle manufacturer's recommended procedures for configuring the alternator to the ECM.
