# TECH TIPS

## Applications:

This bulletin applies to various medium, heavy duty and industrial applications.

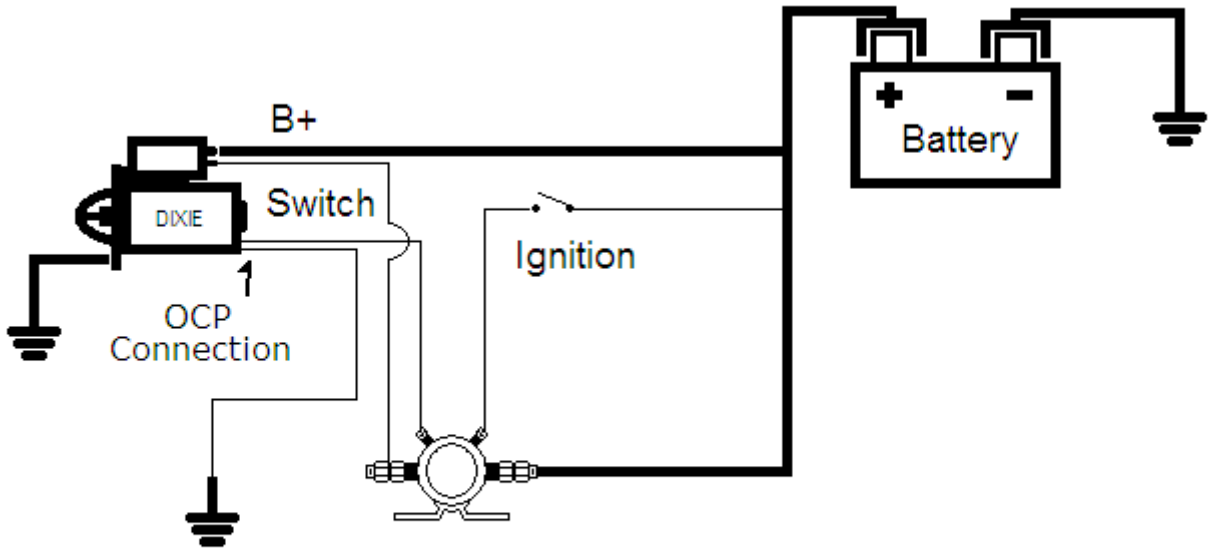
Simplified wiring diagram

The above starters, if installed with the required relay and wiring, have a built in over crank protection (OCP) feature. The OCP feature is designed such that if the starter is cranked too long, with out allowing the starter to cool down to cause an open circuit to the solenoid switch terminal. This *temporarily* prevents the starter motor from functioning until it has sufficiently cooled down, at which point the OCP feature completes the circuit and allows the starter to function. In the case of the intermittent non-cranking issue, this may simply be the OCP functioning as it was designed to.

The OCP feature will not function if the starter is being used to replace a standard non-OCP starter **unless** there is a relay or magnetic switch added to the system.

Follow the manufacturer's recommended procedure for installing the relay or magnetic switch. Below is a typical wiring configuration for an OCP equipped starter. If no relay or magnetic switch is installed the OCP feature is completely bypassed.
