TECH TIPS

Condition:

Cause:

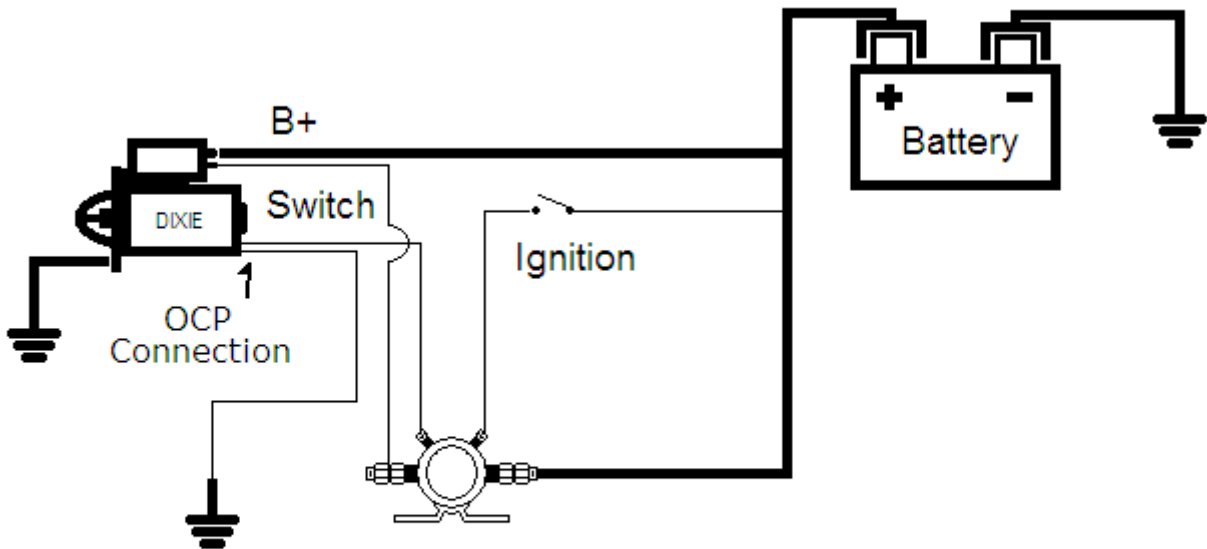
Simplified wiring diagram

The OCP feature will not function if the starter is being used to replace a standard non-OCP starter **unless** there is a relay or magnetic switch added to the system.

Follow the manufacturer's recommended procedure for installing the relay or magnetic switch. Below is a typical wiring configuration for an OCP equipped starter. If no relay or magnetic switch is installed the OCP feature is completely bypassed.
