TECH TIPS

This bulletin applies to various medium, heavy duty and industrial applications.

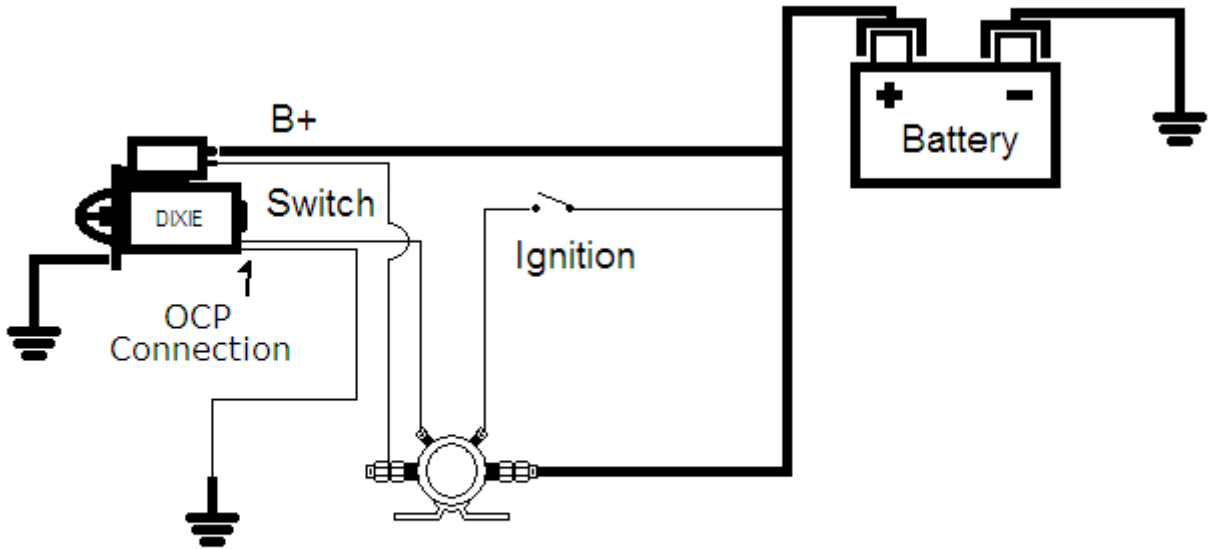
Simplified wiring diagram

The above starters, if installed with the required relay and wiring, have a built in over crank protection (OCP) feature. The OCP feature is designed such that if the starter is cranked too long, without allowing the starter to cool down to cause an open circuit to the solenoid switch terminal. This *temporarily* prevents the starter motor from functioning until it has sufficiently cooled down, at which point the OCP feature completes the circuit and allows the starter to function. In the case of the intermittent non-cranking issue, this may simply be the OCP functioning as it was designed to.

The OCP feature will not function if the starter is being used to replace a standard non-OCP starter **unless** there is a relay or magnetic switch added to the system.

Follow the manufacturer's recommended procedure for installing the relay or magnetic switch. Below is a typical wiring configuration for an OCP equipped starter. If no relay or magnetic switch is installed the OCP feature is completely bypassed.
