# TECH TIPS

**Applications:** 2009 – 2010 Chevrolet Traverse

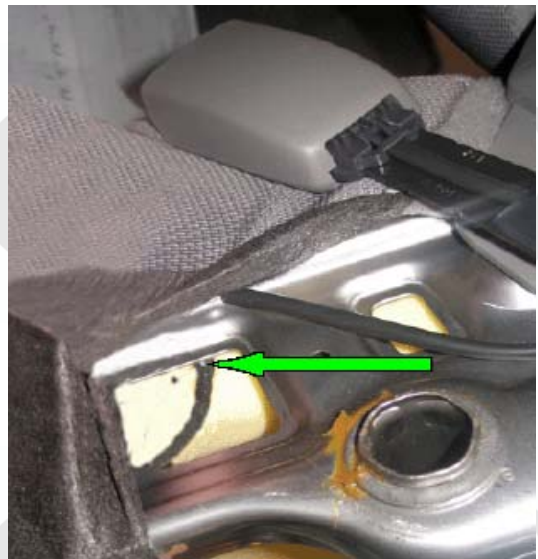
**Cause:** A possible cause for the above condition is a short circuit to ground in circuit 5060.

**Correction:** Examine wiring circuit 5060 (the dark green wire) located on the front of the passenger seat frame. Check for signs of chaffing and or cutting and repair the wiring using heat-shrink tubing. Re-route the wire to prevent reoccurrence.
