TECH TIPS

Applications: 2009 – 2010 Chevrolet Traverse

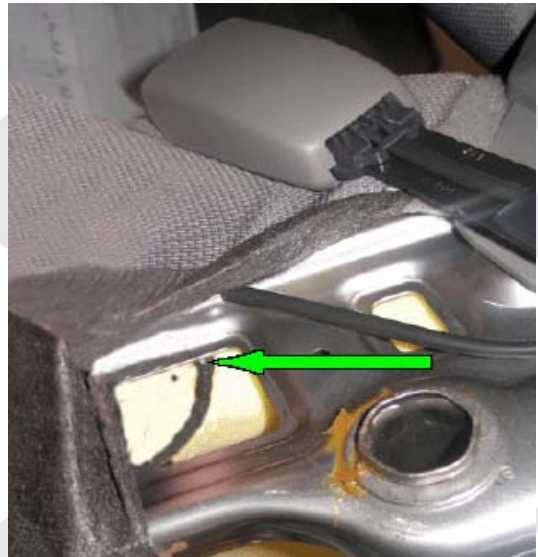
Cause: A possible cause for the above condition is a short circuit to ground in circuit 5060.

Correction: Examine wiring circuit 5060 (the dark green wire) located on the front of the passenger seat frame. Check for signs of chaffing and or cutting and repair the wiring using heat-shrink tubing. Re-route the wire to prevent reoccurrence.
