# TECH TIPS

**Dixie Part Numbers:** S-2074, S-2075, S-2076 and S-2109

**Applications:** 1998 – 2000 Ford Contour  
1999 – 2000 Mercury Mystique  
1999 – 2000 Mercury Cougar

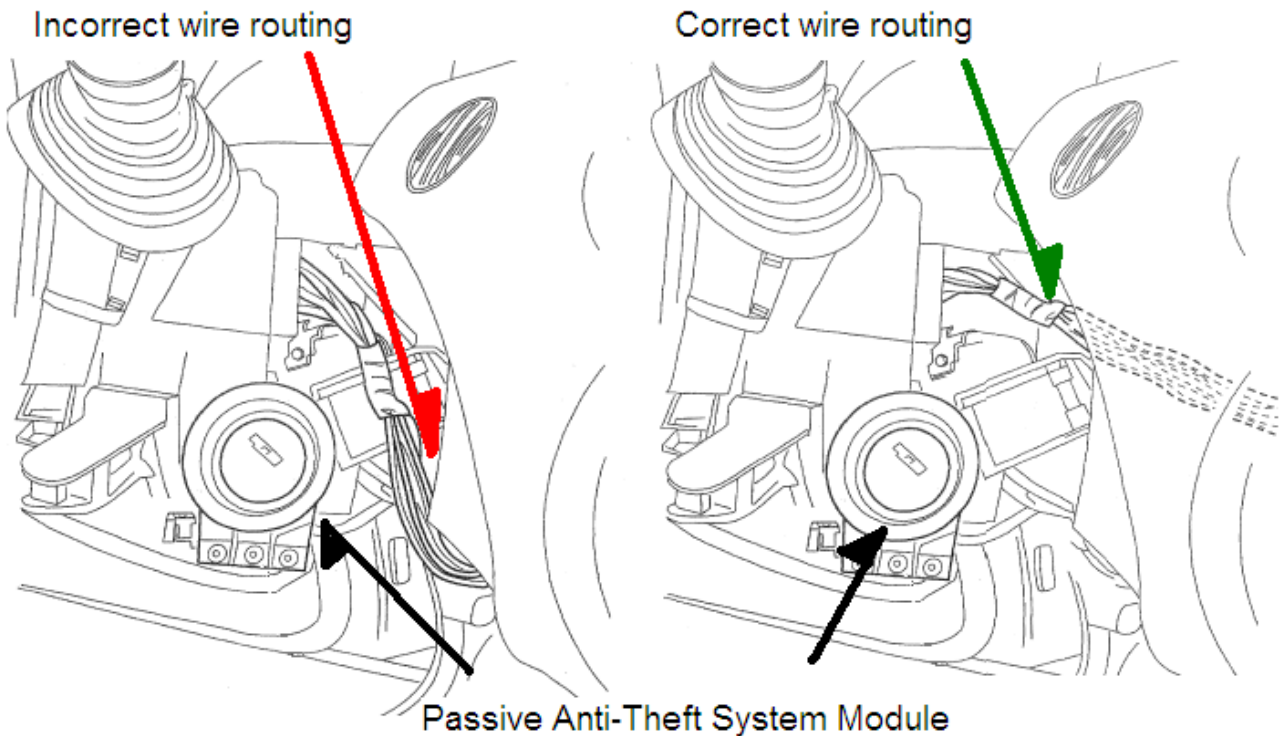
**Condition:** The operator of the vehicle may complain of an intermittent no start condition. Inquire if this was when the wipers were left in the intermittent or low speed setting during start up.

**Cause:** The wiper motor wiring may have been routed to closely to the passive anti-theft system module.

**Correction:** Verify if the vehicle does not start with the wipers in either of the above modes. If it fails to start inspect the wire routing as shown below and if incorrectly routed tie-strap the wire further away as shown.
