TECH TIPS

Dixie Part Numbers: A-293 A-2075

Applications: 1999 – 2003 Ford Windstar Applications with 3.0 and 3.8L

TSB_231.doc

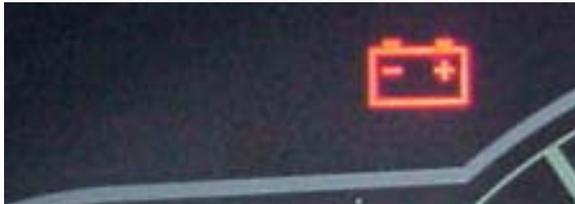
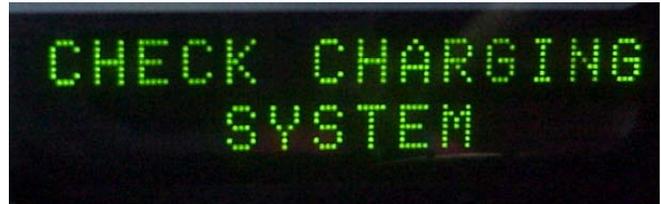
Condition: The operator of the vehicle may comment that the alternator has recently been changed and the light comes on and/or the message screen shows “CHECK CHARGING SYSTEM”.

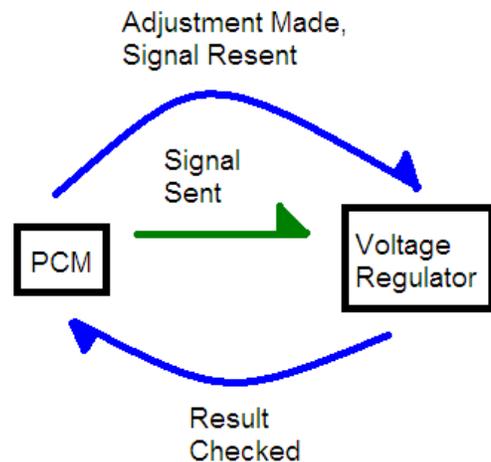
On all applications the Windstar Powertrain Control Module (PCM) and regulator function a little differently than most vehicles. A typical PCM type system works as a loop. The PCM tells the regulator what voltage to operate at, the regulator sends a signal back to the PCM showing what voltage it is operating at and then the PCM sends another signal if the output voltage is still not what the initial instruction was (for adjustment or to compensate for voltage drop on the wiring).

The Windstar PCM only sends the signal once and then if the signal back is not what the PCM commanded the light and error messages come on.

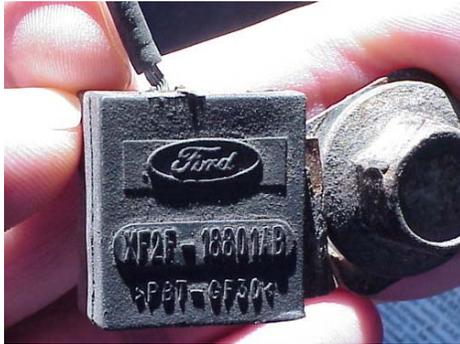
In addition to this there is a capacitor to reduce interference on the ground of the alternator. The lead that goes between the alternator frame and the body frame is prone to fail from fatigue.

Ensure that the capacitor lead has not deteriorated and broken.
