TECH TIPS

Dixie Part Numbers: A-8669 A-8947 3543-5210 PLG-303

Applications: 1997 – 1998 Mazda Protégé 1.5L
1999 – 2001 Mazda Protégé 1.6L
1997 – 2000 Mazda Protégé 1.8L
2001 – 2003 Mazda Protégé 2.0L

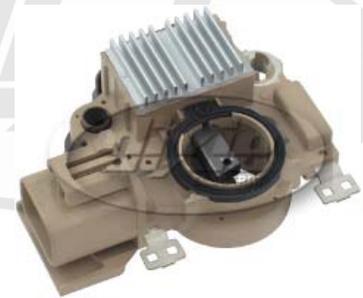
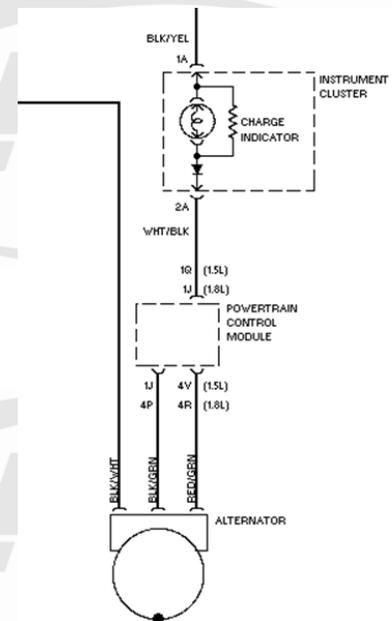
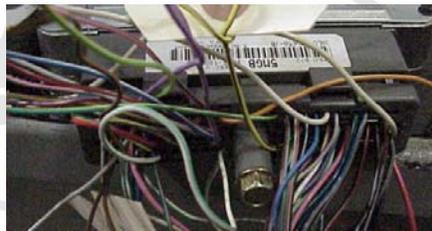
Cause: The alternator on this application is a different design than the majority of alternators with the key difference being that the alternator voltage is controlled by the Power Train Control Module (PCM). Additionally, the light circuit, which is typically controlled by the alternator, is also controlled by the PCM. Visually the device looks like a regulator which would typically have an LS connection. The device, shown on the right actually has a PD connection (Dixie Number 3543-5210) and internally there is only a single transistor, which is fed by the PCM to the D connection. There is no light connection on the alternator, as can be seen in the wiring diagram, on the right. The alternator sends a signal to the power train control module, and it controls the lamp function on the vehicle. Below is what the PCM wiring looks like...

What is the significance of the mess of wires? There are numerous ground wires, one of them being black with a red trace. If this wire is followed through the firewall it is connected to the body of the car on the fender in close proximity to the alternator and is used as a voltage sense wire. When disconnected or with high resistance, such as when the wire corrodes the voltage begins to climb. When fully disconnected the alternator voltage will climb to 18V and the light will come on, indicating that there are troubles in the charging system.

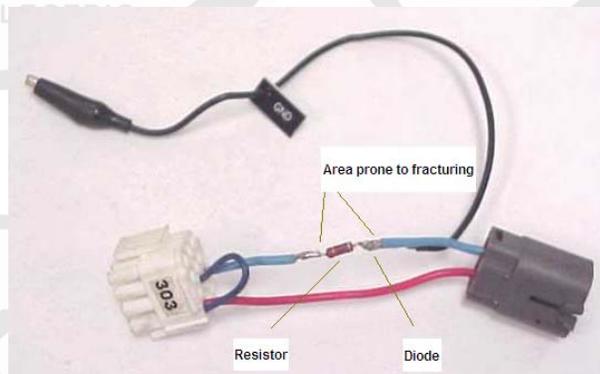
One of the observations made here is that despite the warnings above the alternator is put on a tester, connected using a standard plug and run. This will make the unit charge for a few moments and then blow the alternator electronics. Typically the comment on these is the unit was overcharging and then stopped working. The alternators **must** be tested using either a proper D&V tester with plug 303 or with a Transpo test adapter VRC101-26. On the D&V test lead ensure that the ground wire is connected or the diode will be blown. Also periodically inspect the lead as they are prone to fracture as shown below.

Correction: Use extreme care when testing and diagnosing the charging system on this vehicle.
