TECH TIPS

Dixie Part Numbers: A-2054

Applications: 2001 – 2006 Ford Ranger 2.3L

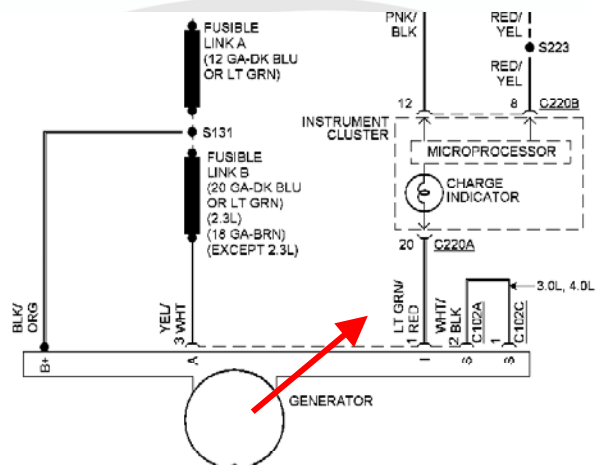
Cause: A possible cause for this condition is an intermittent short circuit to ground in the vehicles wiring. The green wire with the red trace is used to provide information to the vehicles' on-board computer and if grounded triggers the light and causes voltage fluctuations.

Correction: Inspect the vehicle wiring for damaged insulation and repair any damaged sections and protect them from chaffing as appropriate. **TIP** running a clean hand over the wire may assist in finding damaged portions of the wire. When damaged, the copper wire deteriorates, leaving a film of green oxide, which will transfer when rubbed.
