# TECH TIPS

**Dixie Part Numbers:** S-80063 S-80319

**Applications:** 2003 – 2006 Acura MDX

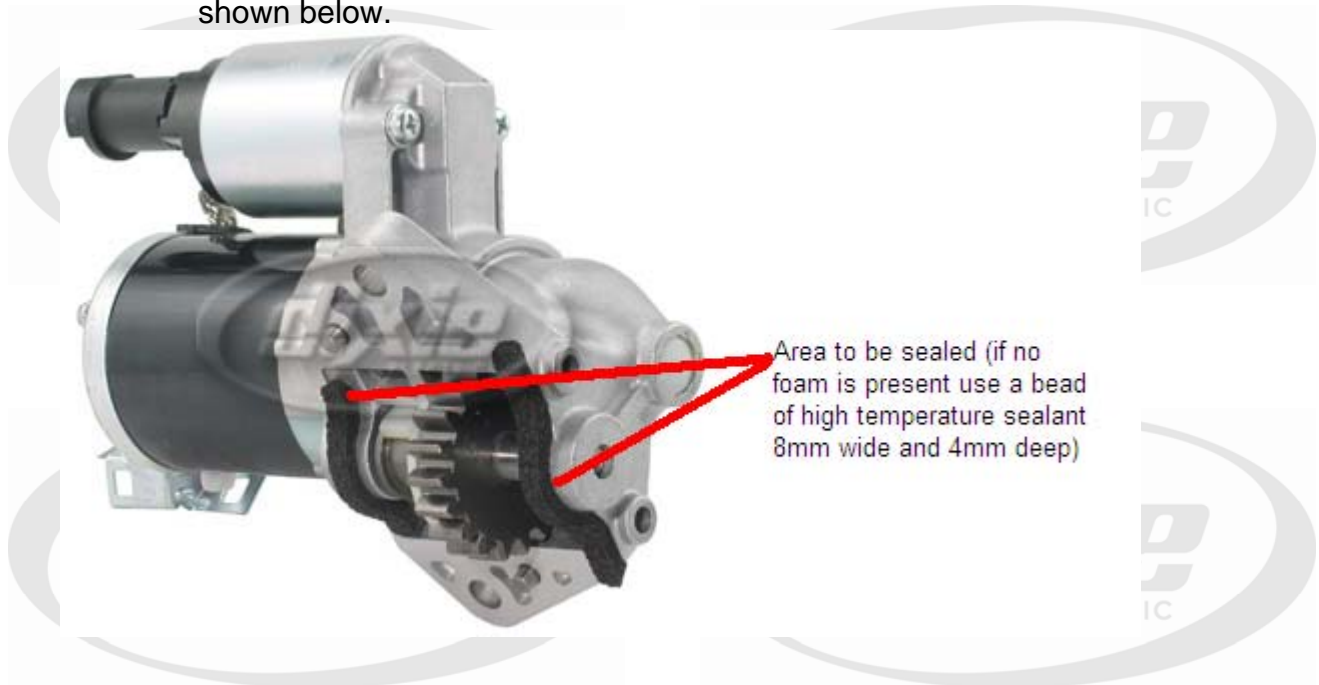
**Condition:** The operator of the vehicle may complain that the vehicle fails to start.

**Cause:** A potential cause for the above condition is debris coming through the torque converter and contaminating the starter.

**Correction:** Prior to commencing ensure that you have the antitheft codes for the radio and navigation systems. Follow the manufacturers recommended starter replacement procedure, which include removing the torque converter cover (from the bottom) and the starter. A shop-vac is to be used to suck the debris from the bottom and compressed air is to be blown in through the starter opening. (Safety glasses and a dusk mask are required). The starters may come with a “foam” shield to prevent recurrence or high temperature sealant can be used to prevent this problem in the location shown below.
