TECH TIPS

Applications: 2008 - 2009 Suzuki AN400
2008 - 2009 Suzuki DL1000
2008 - 2009 Suzuki GSF1250S
2008 - 2009 Suzuki GSX650F
2008 - 2009 Suzuki GSX-R600
2008 - 2009 Suzuki GSX-R750
2008 - 2009 Suzuki VLR1800
2008 - 2010 Suzuki GSX1300R
2008 - 2010 Suzuki VL800
2008 Suzuki GSX1300BK
2009 - 2010 Suzuki SFV650F
2009- 2010 Suzuki VZ1500

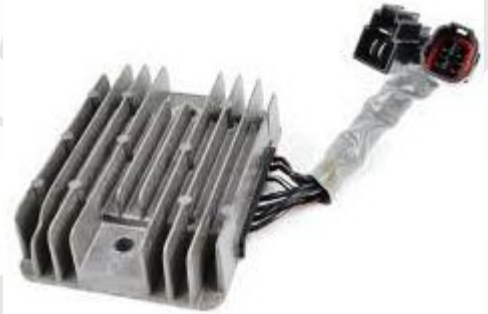
Cause: A potential cause for the above conditions is a manufacturing flaw in the voltage regulator/rectifier assembly. The assembly was manufactured with inadequate adhesive between the circuit board and heat sink resulting in poor heat transfer and damage to the voltage control circuit. Affected voltage rectifier/regulator assembly numbers are:

32800-05G10	32800-05H11	32800-05H20
32800-06G01	32800-10G10	32800-15H00
32800-15H10	32800-18H00	32800-41F11
32800-41G10

Correction: Follow the manufacturer's recommended diagnostic and repair procedures when applicable.
