TECH TIPS

Dixie Part Numbers: S-80025 and S-80026

Applications: 2002 – 2003 Nissan Maxima

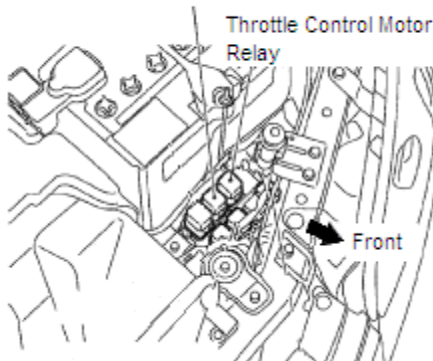
Park/Neutral Relay (automatic transmission)
Clutch Internlock Relay (manual transmission)

A potential cause for the above are faulty/sticking relays. There is an OE Service Bulletin showing that when the above situation occurs the Park/Neutral Relay (automatic transmission) – Clutch Interlock Relay (manual transmission) and the Throttle Control Motor Relay are faulty.

The vehicle manufacture suggests changing the 2 relays to correct the problem. The part number has not been revised so at this time there is no way to check if a vehicle has had this work performed already (if the owner does not recall). The part number for the relays is 25230-79917 and 2 pieces will be required. When facing the engine from the front they are the 2 relays (in the series of 3) closest to the battery and on the right side.
