# TECH TIPS

**Dixie Part Numbers:**      A-8245      A-8302      A-8304  
   A-8321      A-8330

**Applications:**      1990 – 1994 Eagle Talon  
   1990 – 1994 Plymouth Laser

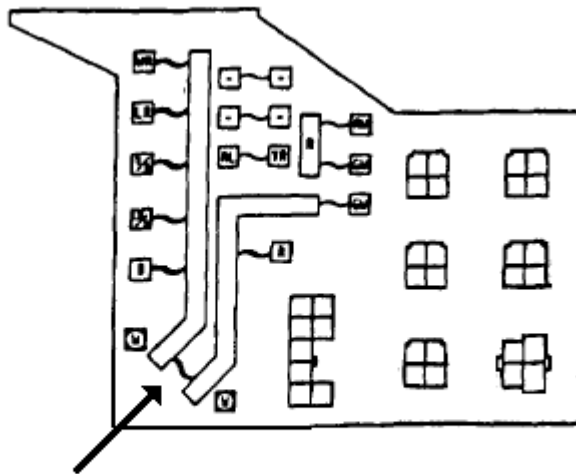
Alternator Circuit  
Sub-fusible link

**Condition:**      The technician may have problems trouble shooting the charging system.

**Cause:**      A possible cause for this is the generator circuit sub-fusible link (80A) located in the generator circuit.

**Correction:**      Check the generator circuit sub-fusible link located on the right hand side of the engine compartment. See the sketch below for the location of the alternator circuit sub-fusible link.
