TECH TIPS

Dixie Part Numbers: S-8772 S-80409

Applications: 2005 – 2008 Toyota Avalon
2007 – 2008 Toyota Camry
2007 – 2008 Toyota Camry HV
2008 Toyota Highlander
2008 Toyota Highlander HV
2008 Toyota Land Cruiser

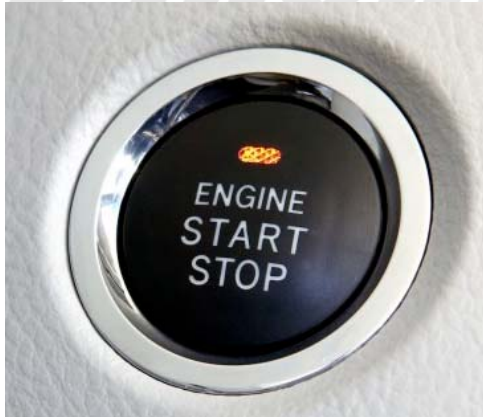
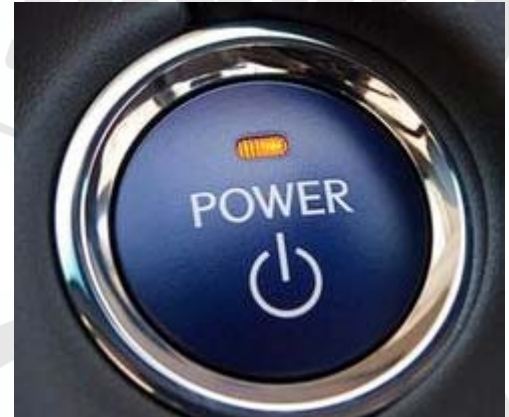
Condition: The operator of the vehicle may complain of an intermittent no crank condition when attempting to start the vehicle from the pushbutton *Engine Start Stop* button on applications with conventional combustion engines only, or the *Power* button on hybrid applications.

Cause: A possible cause for the above condition is poor contacts in the switch.

Correction: The manufacturer has released newer switches with improved contacts to remedy this situation. Follow the manufacturer's recommended procedures for checking and replacing the *Engine Start Stop* button or the *Power* button.
