TECH TIPS

Dixie Part Numbers: A-8376 A-8377
S-8386 S-8387 S-8711

Applications: 1990 – 1993 Nissan Pickup 2.4L

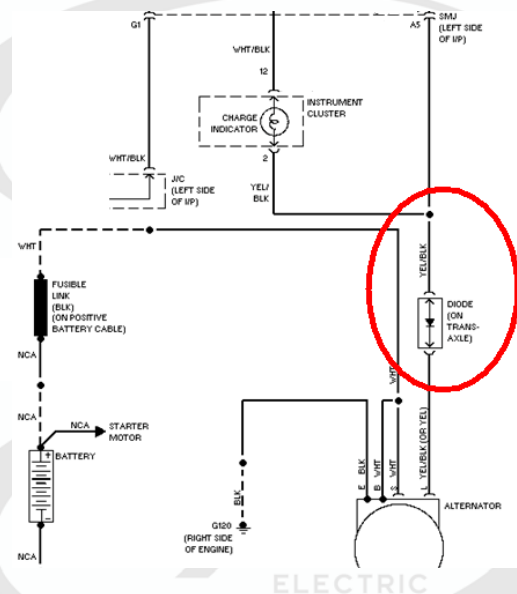
Cause: A potential cause for the above conditions is a damaged wiring harness. The vehicle was manufactured with a wire tie for the harness that was attached to the wire instead of the diode. Constant vibration may have damaged the ignition portion of the Y connection, and results in a failure to charge at alternator speeds of less the 3500 RPM.

Correction: The manufacturer suggests inspecting the wiring harness near the “Y” connection close to diode 59E (refer the vehicle’s wiring diagram).

The manufacturer recommends inspecting and repairing the wiring harness and properly securing the diode to the engine wiring harness connector to prevent future occurrences.
