TECH TIPS

Dixie Part Number: S-8654 S-8818 S-80164

Applications: Various Hyster and Yale applications with Mazda Engines

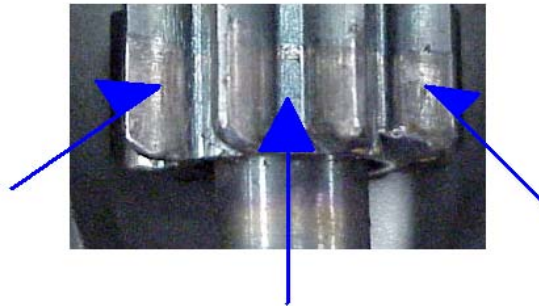
The technician may observe that when removing the starter the pinion shows wear on both sides of the pinion as well as between both teeth as shown in the picture below.

Cause: The above conditions may be caused by improperly adjusted pinion clearance.

Correction: The above starter has slotted mounting holes and the pinion clearance must be properly adjusted when installing the starter! To adjust the pinion clearance mount the starter in the bell housing **but** only tighten the mounting bolts finger tight. Ensure that the starter is tight against the flange and that the pilot ring is completely engaged in the bell housing bore. Crank the engine over, then torque the starter mounting bolts.
