# TECH TIPS

- Applications:**
- 2008 – 2009 Chevrolet Tahoe Hybrid**  
(VIN #'s 8R117658 to 8R279199 and 9R100025 to 9R249064)
  - 2008 – 2009 GMC Yukon Hybrid**  
(VIN #'s 8R117663 to 8R279162 and 9R100022 to 9R249955)
  - 2009 Cadillac Escalade Hybrid**  
(VIN #'s 9R100056 to 9R2490338)
  - 2009 Chevrolet Silverado Hybrid**  
(VIN #'s 91103737 to 91133871 and 9G194966 to 9G234917)
  - 2009 GMC Sierra Hybrid**  
(VIN #'s 91103750 to 91133918 and 9G171821 to 9G235011)

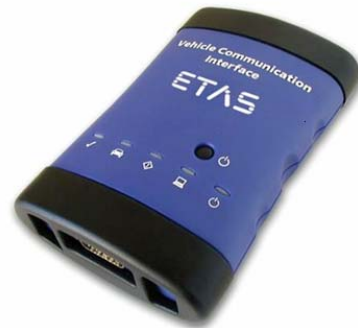
**Correction:** If the correction has been performed there should be a label indicating so located under the hood. The calibration file is not available from GMSP0 and must be accessed via the *Multiple Diagnostic Interface* (similar to the one shown on the right) and *TIS2WEB* and can be installed with a *Tech 2* scan tool.
