TECH TIPS

Dixie Part Numbers:	A-6227	A-6228	A-6229	A-6441
	A-6442	A-6443	S-6100	S-6139
	S-6140	S-6142	S-6143	S-6156
	S-6197	S-6198	S-6199

Applications: 1996 – 1997 Volkswagen Golf (all options)
1996 – 1997 Volkswagen GTI (all options)
1996 – 1997 Volkswagen Jetta (all options)

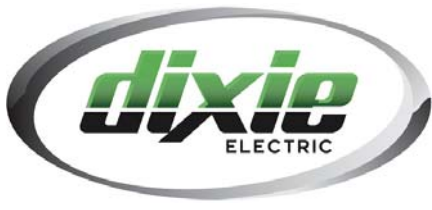
Cause: A potential cause for the above conditions is the battery clamps at the battery positive and negative terminals.

No Clearance between jaws of the battery clamp

A minimum of 1mm clearance between the jaws of the battery clamp

Correction: Inspect the battery clamps that attach to the battery posts. If there is no clearance between the jaws disconnect the cables and file 1mm of material so that there is a gap as shown in the sketch on the right.
